Situation Photo Log

Friday, May 11, 2012

Kalamazoo River / Enbridge Spill

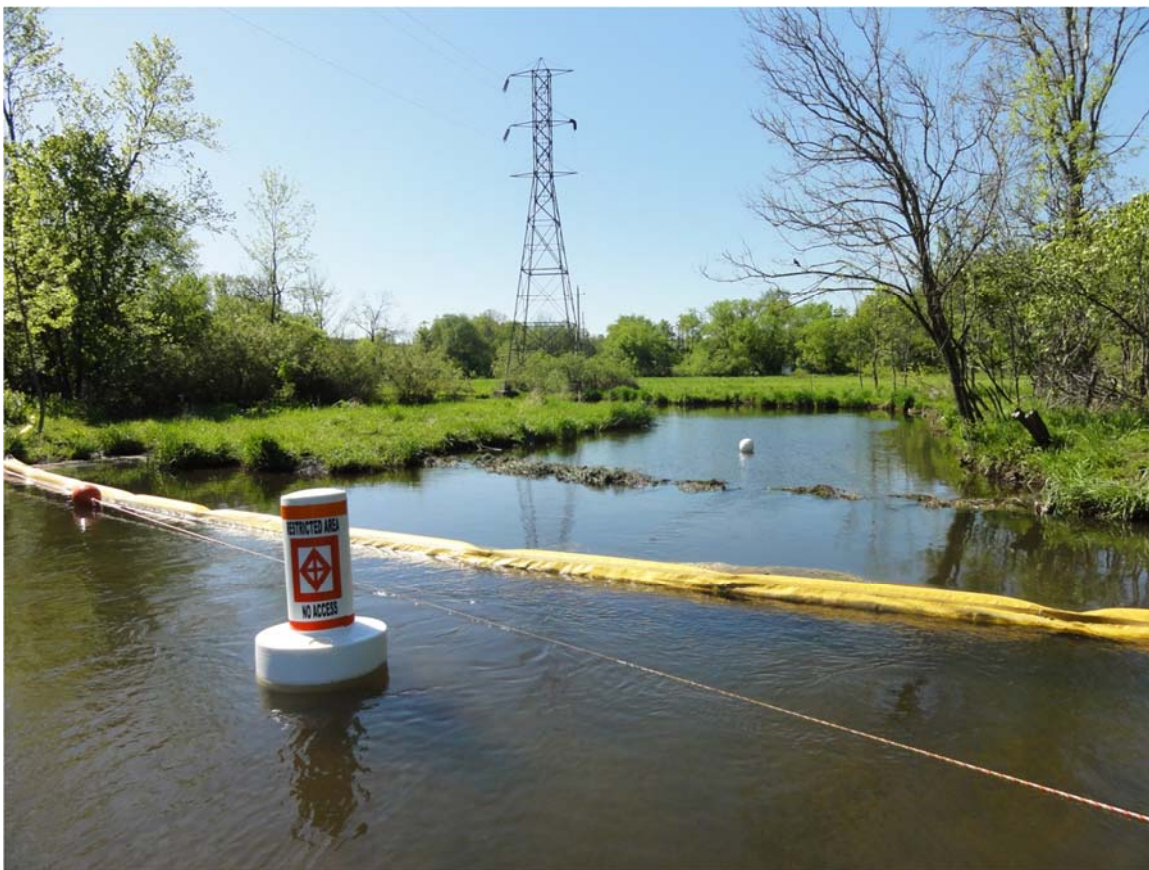
1. MP10.75 sediment trap, water levels receding.

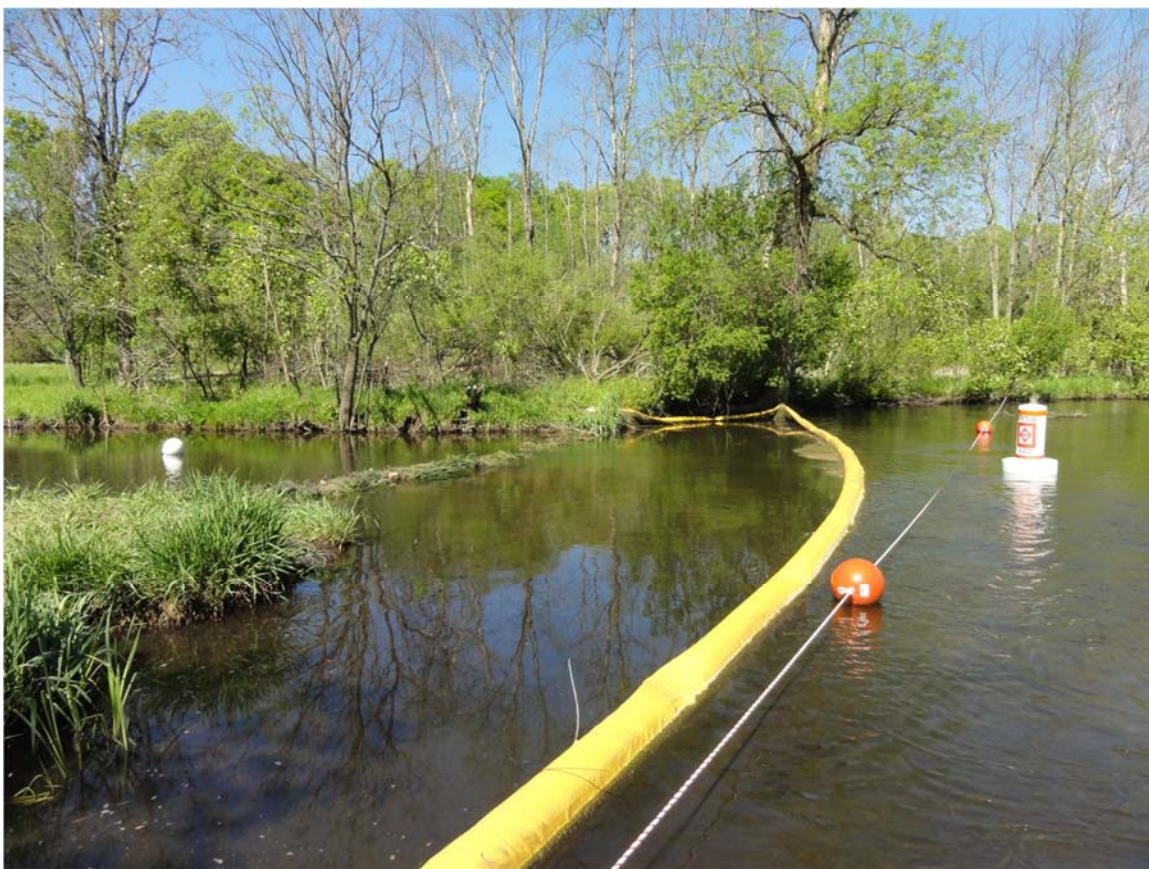
2. MP10.75 sediment trap, water levels receding.

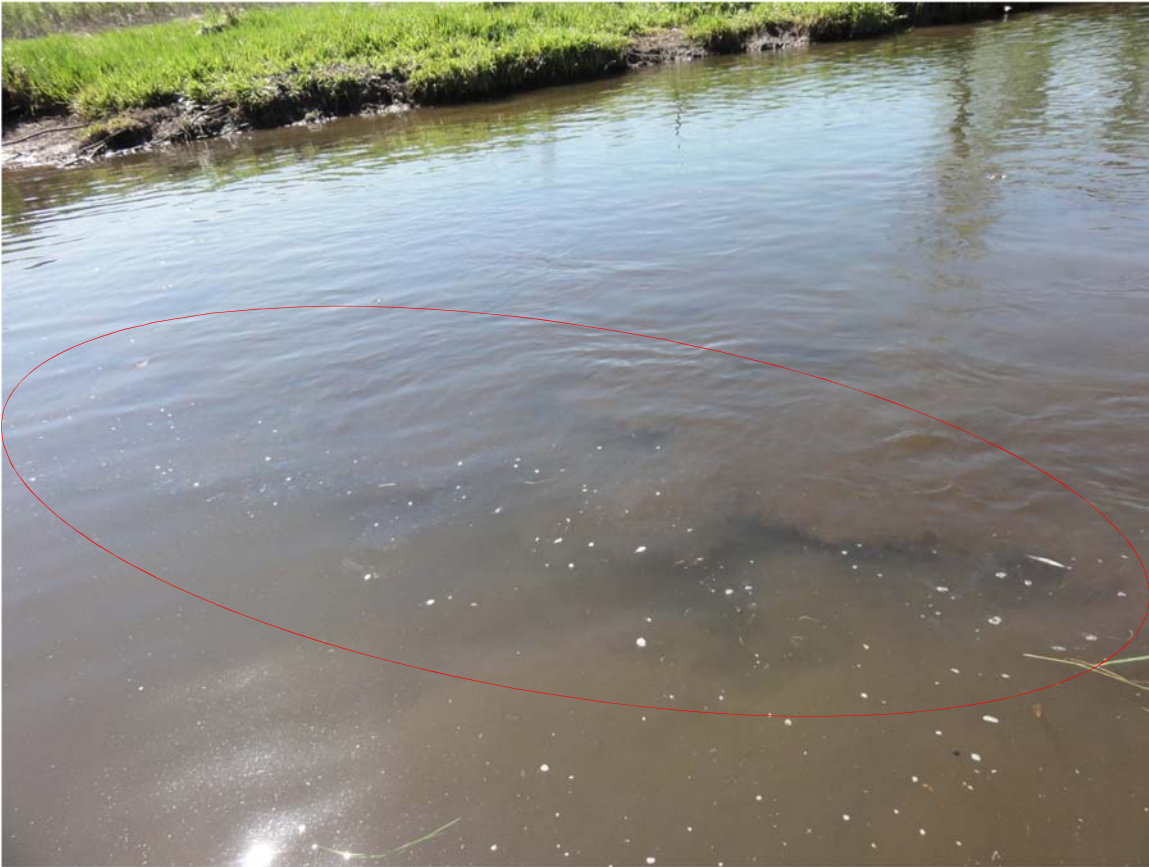
3. MP13.4 "Lonely Tree" jet boat reverse thrust agitated sheen to the surface.

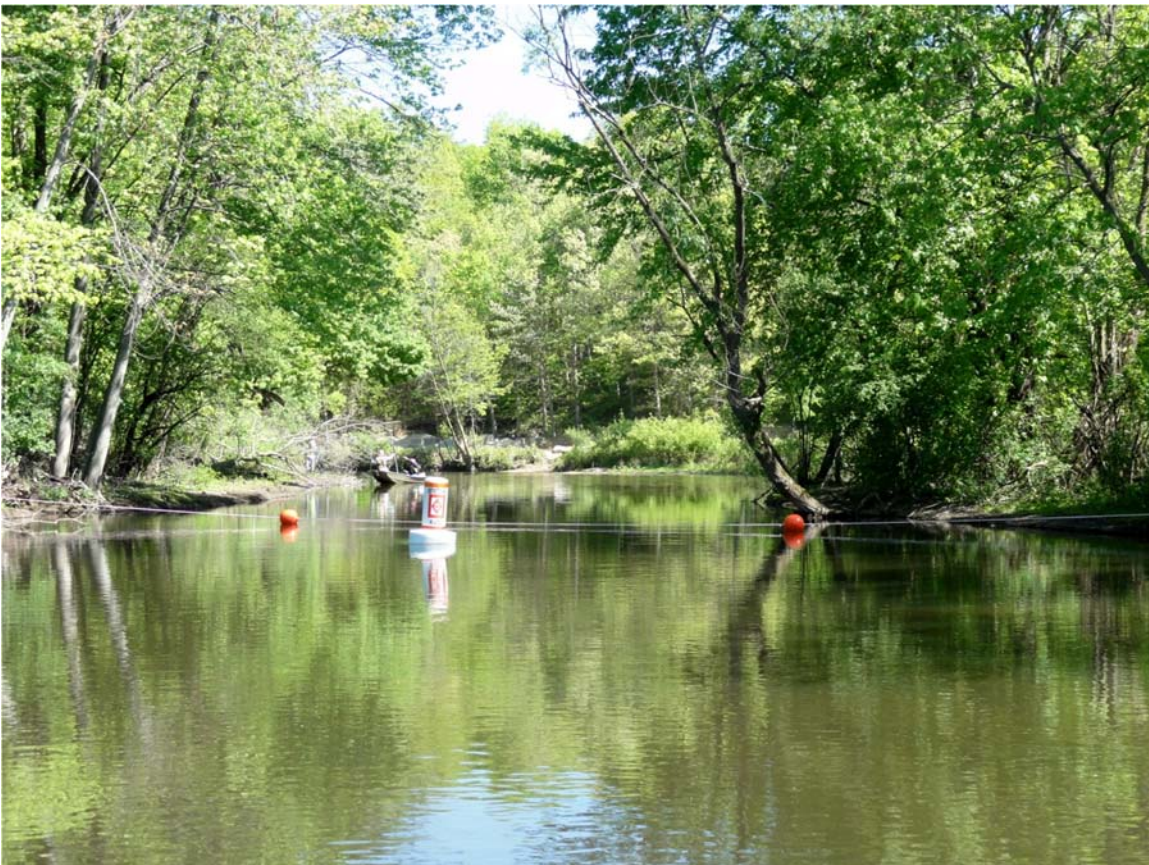
4. MP14.75 buoys deployed at upstream end of channel.

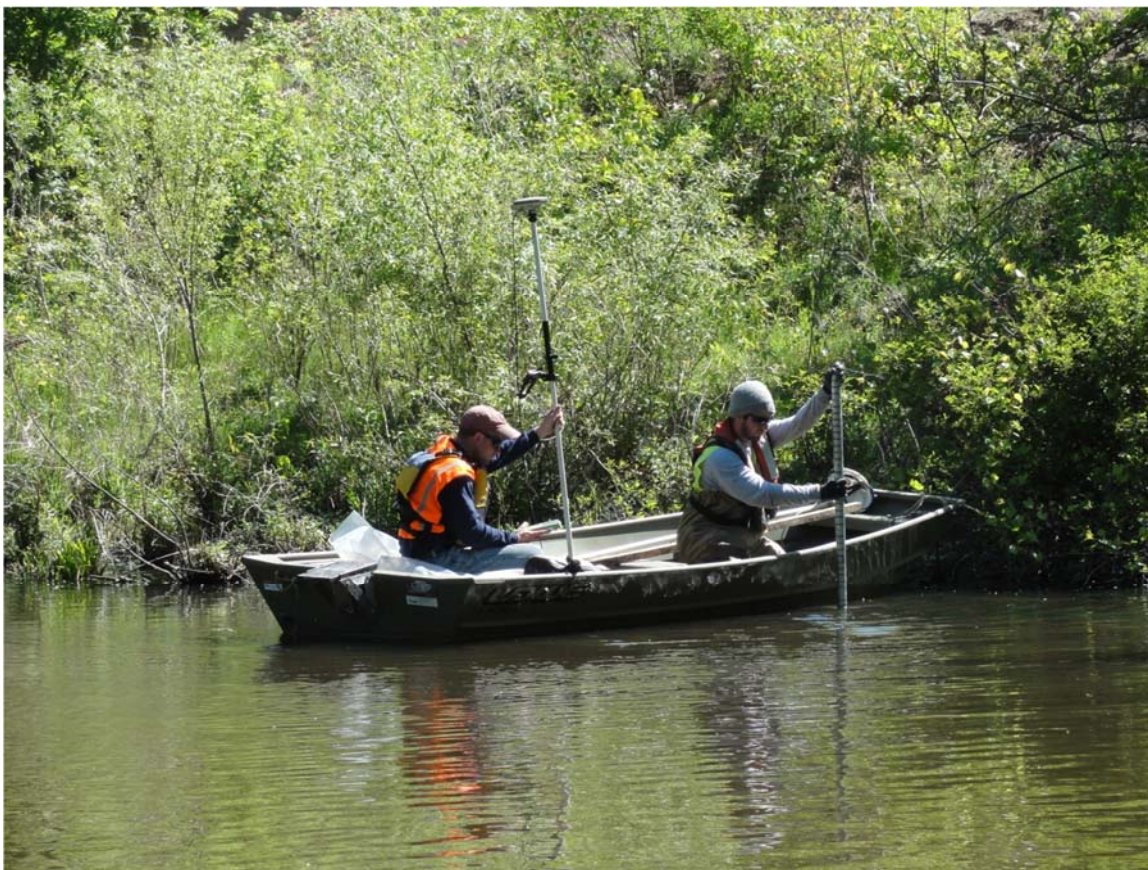
5. MP14.75 crews collecting baseline sediment readings.

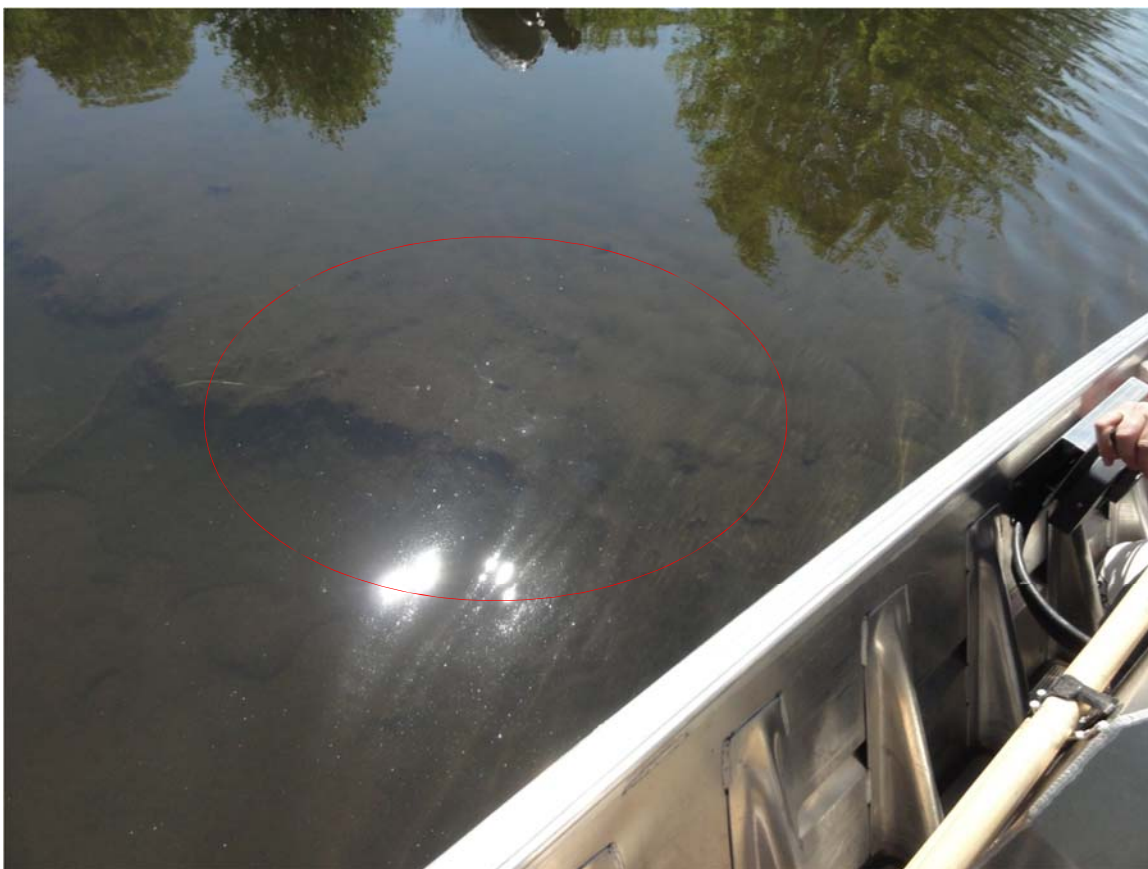
6. MP14.75 sheen observed in river channel.

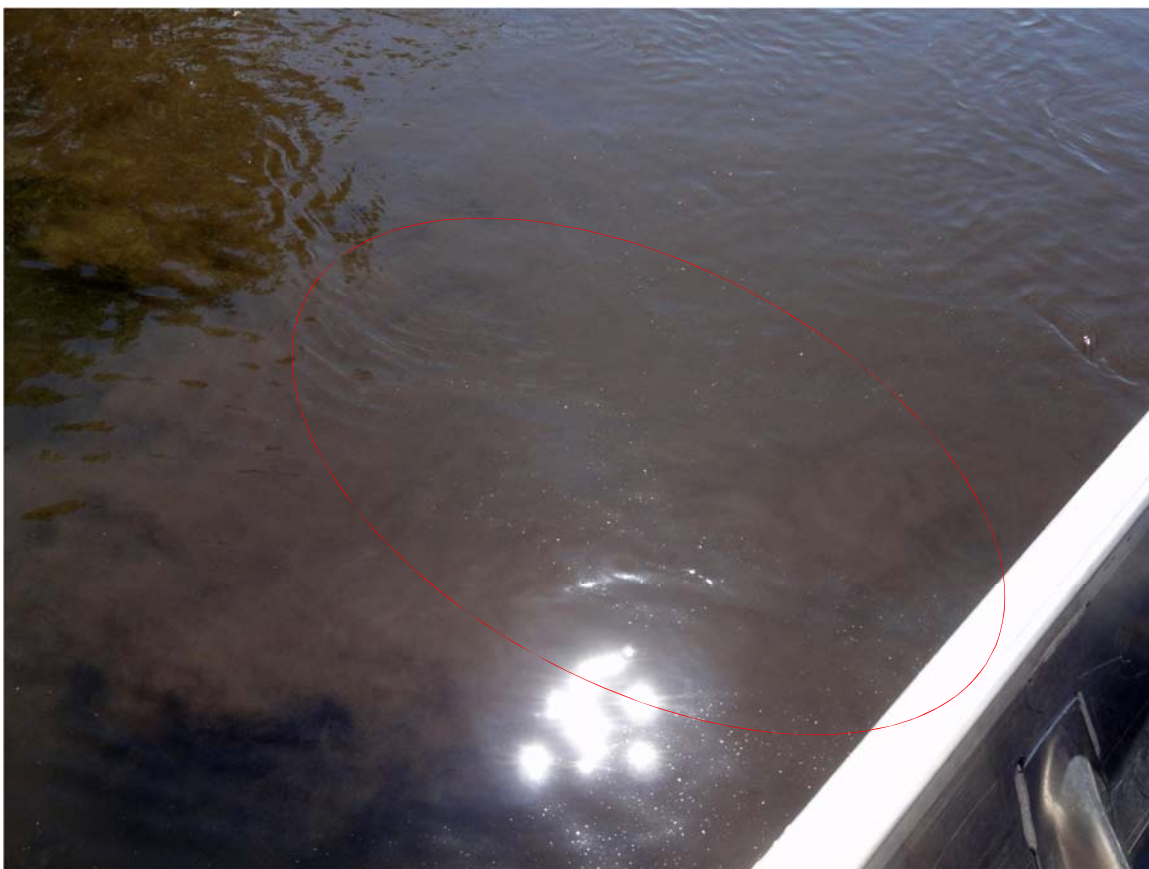
8. OB14.98I jet boat reverse thrust agitated sheen to the surface.

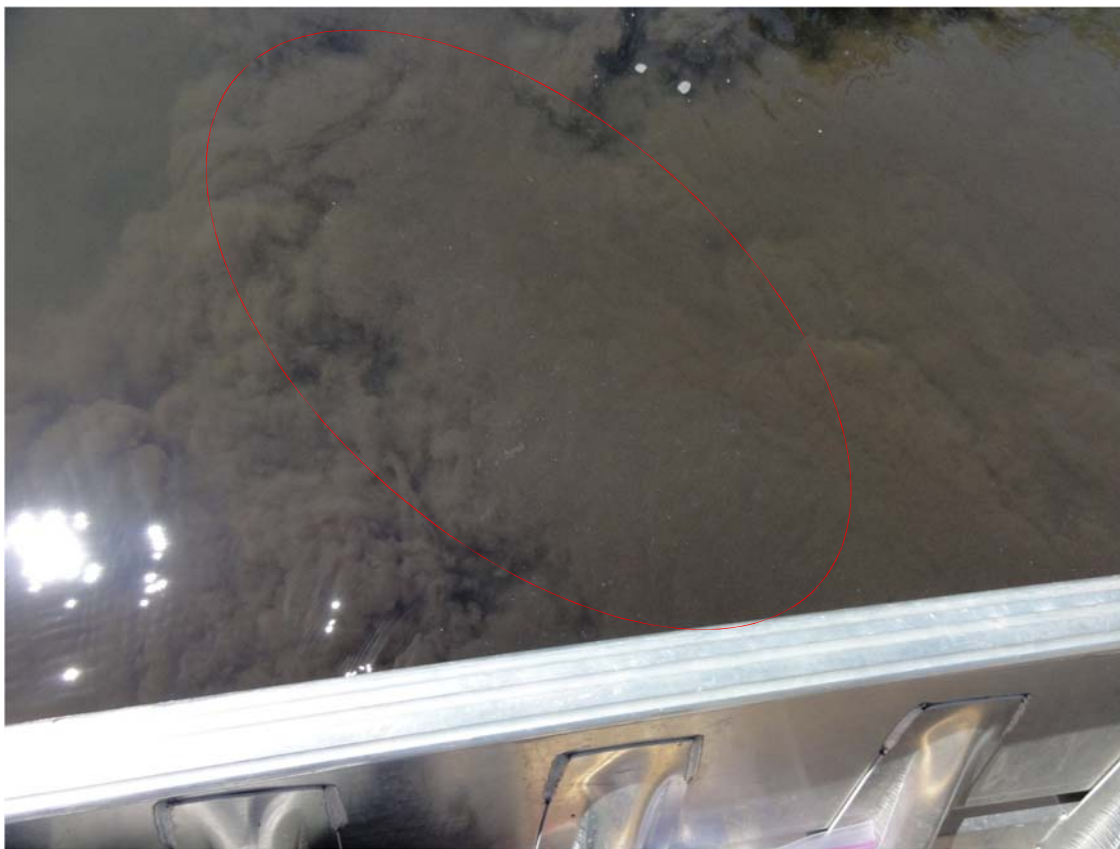
9. MP15.0 LDB jet boat reverse thrust agitated sheen to the surface.

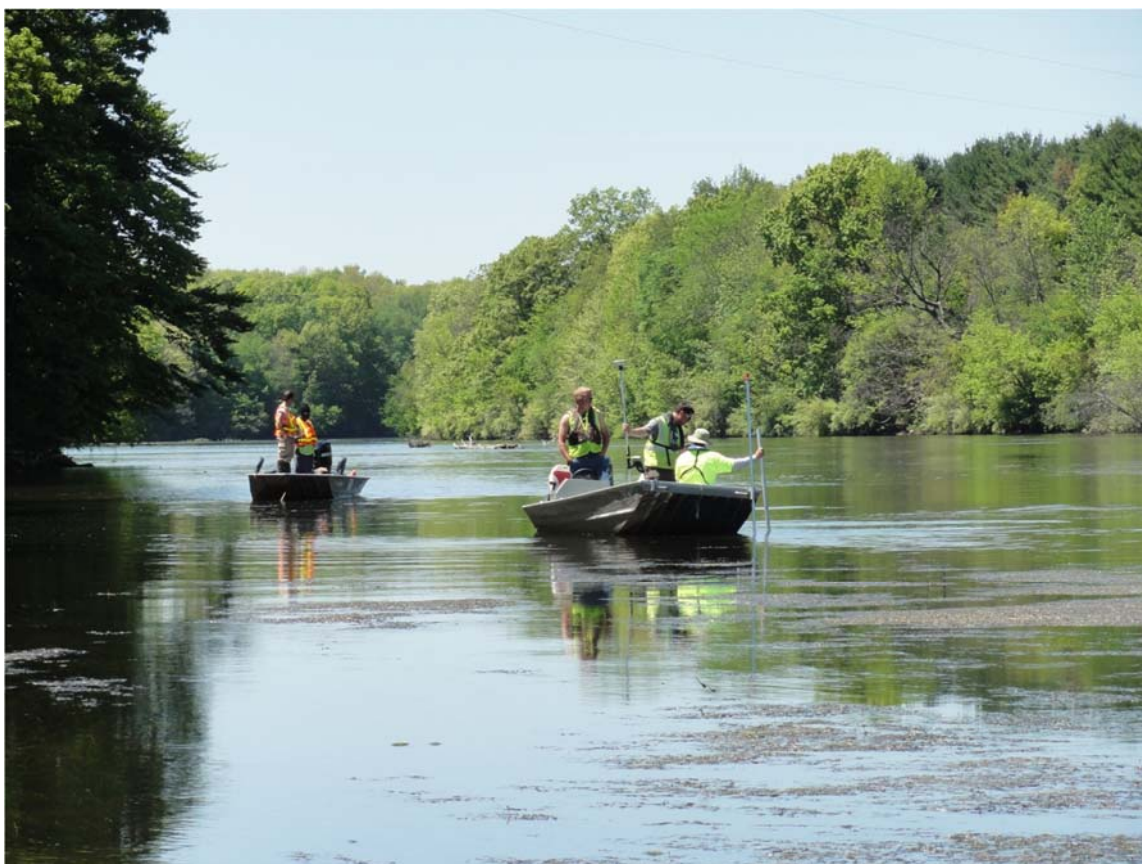
10. MP4.0 Poling crew and support boat observed.

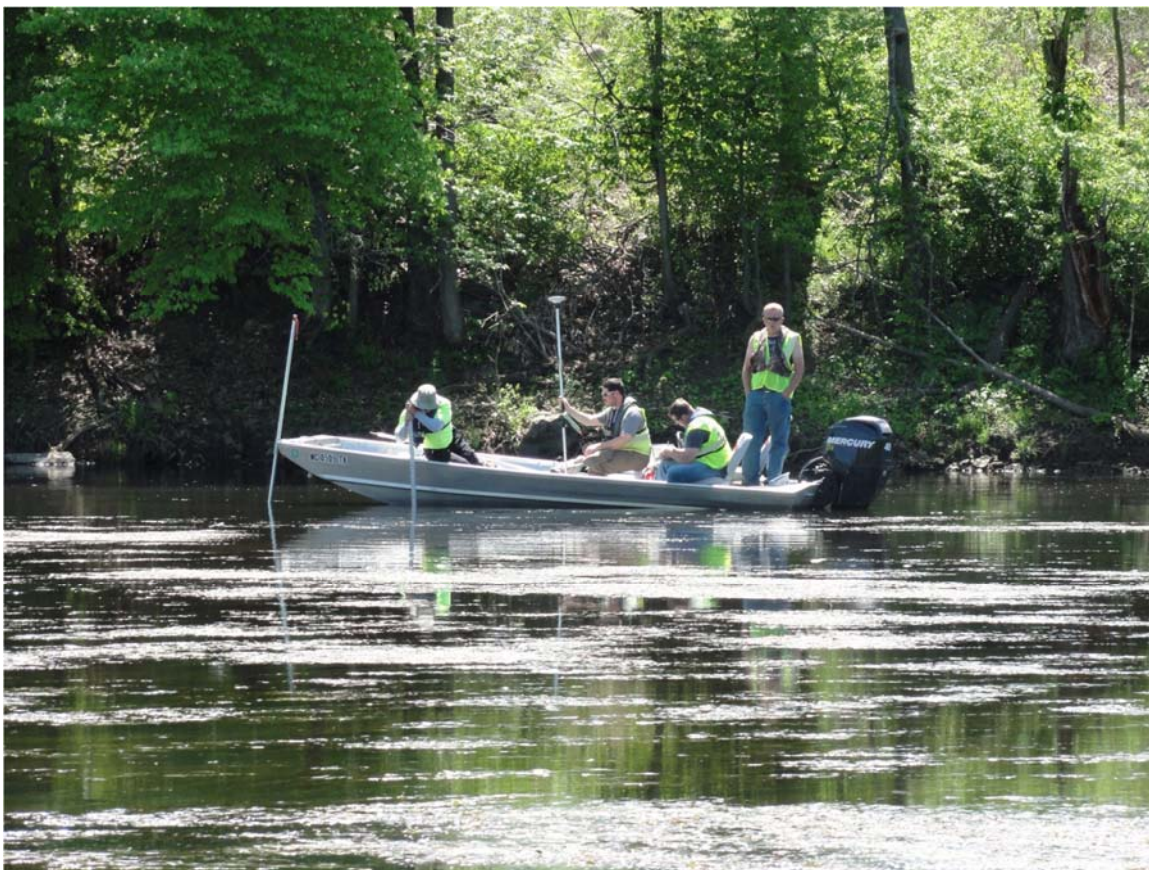
11. MP4.0 Poling crew.

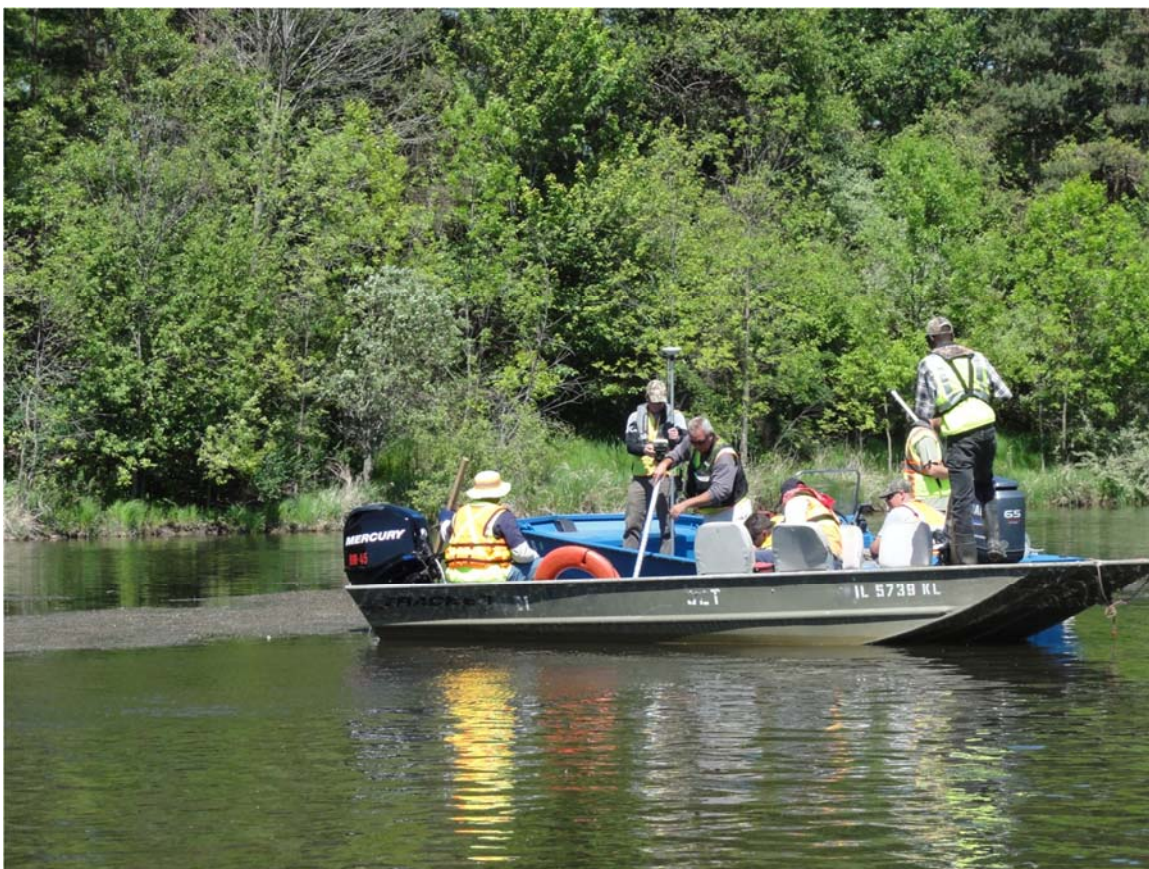
12. MP3.25 Poling crew and support boat observed.

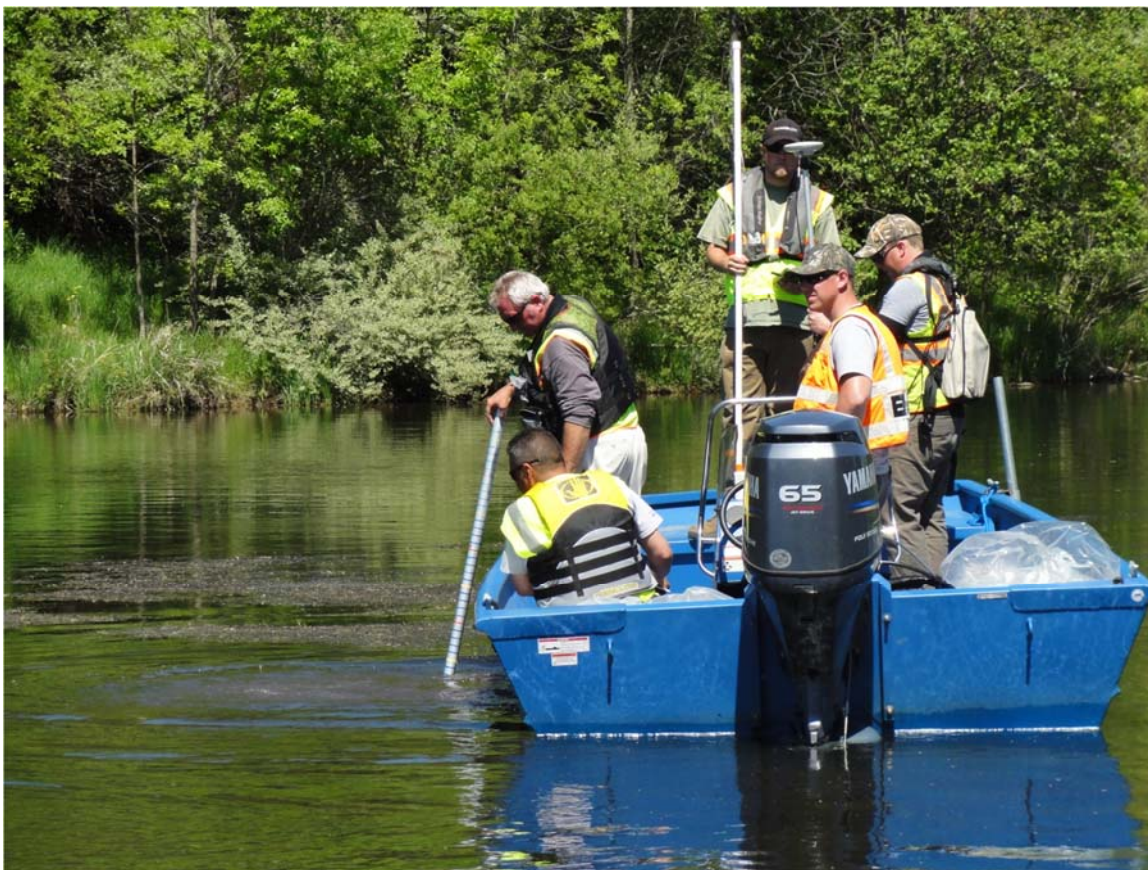
13. MP3.25 Poling crew.

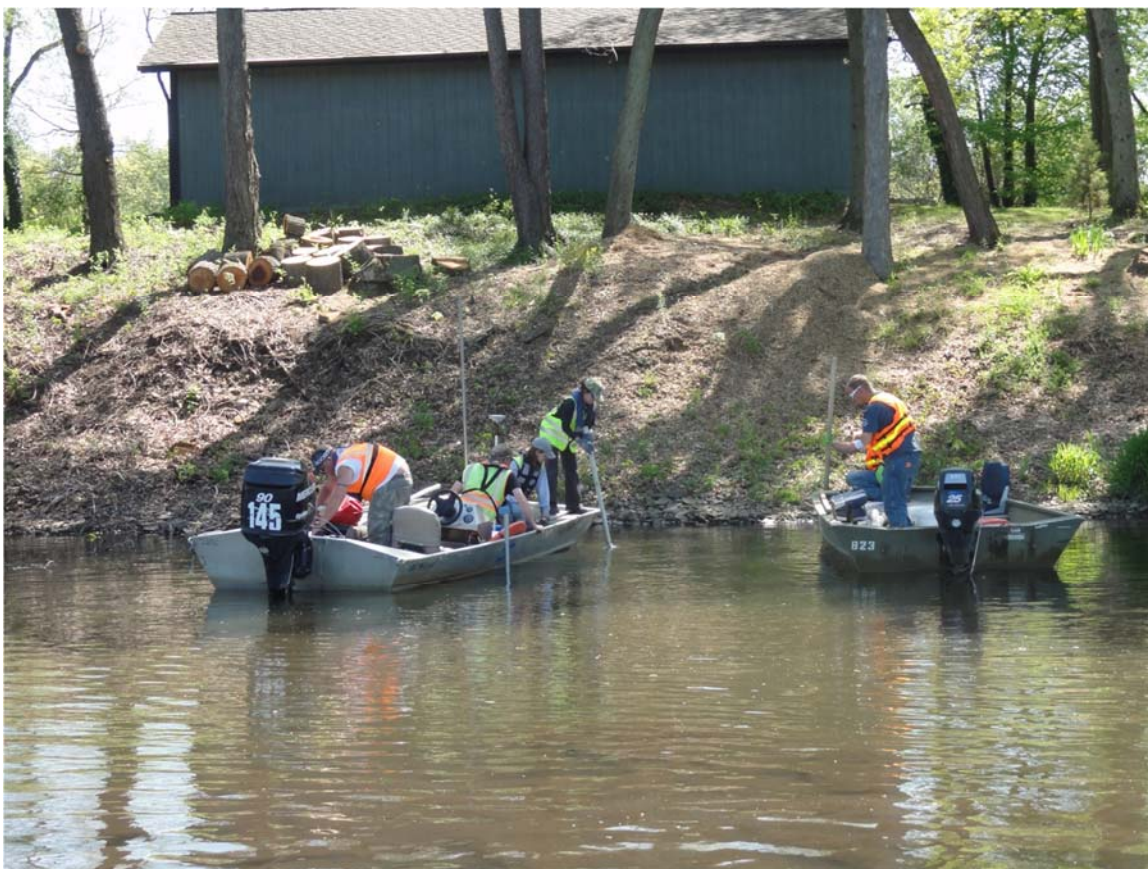
14. Ceresco Dam Poling crew and support boat observed.

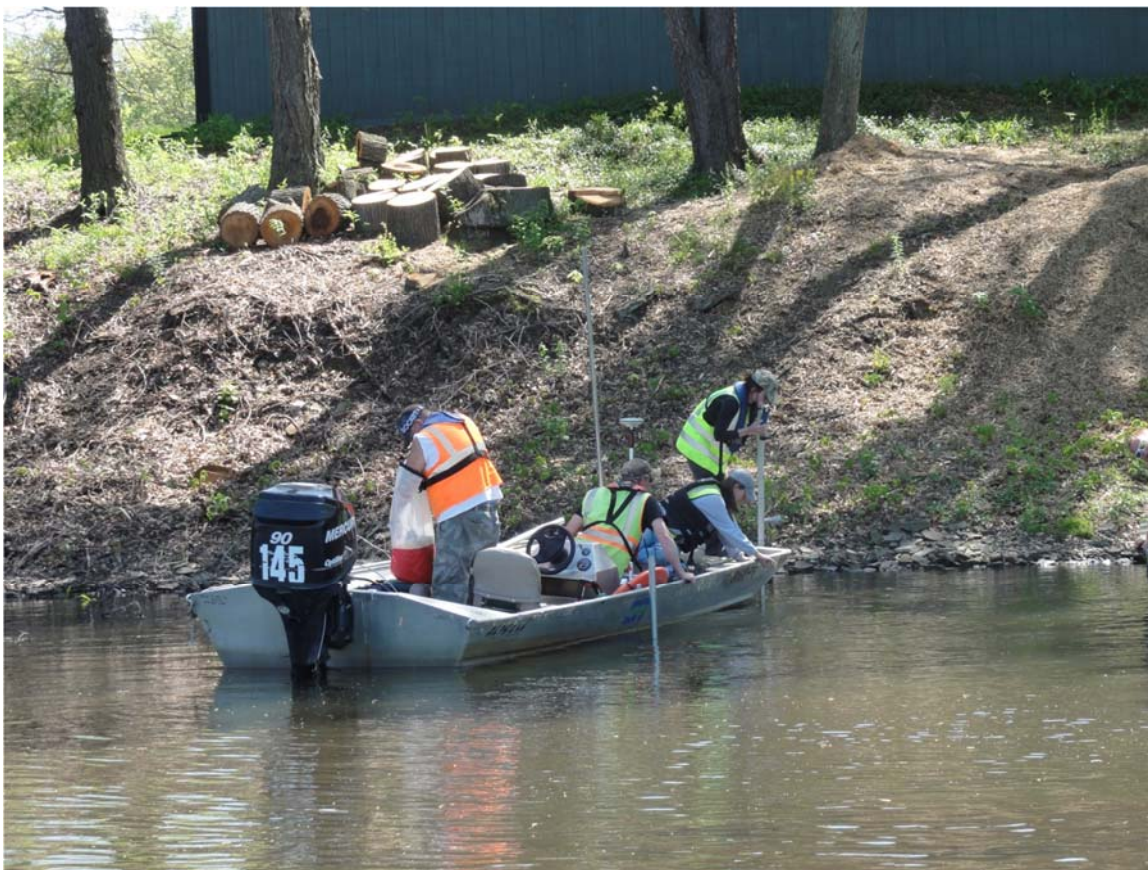
15. Ceresco Dam Poling crew.

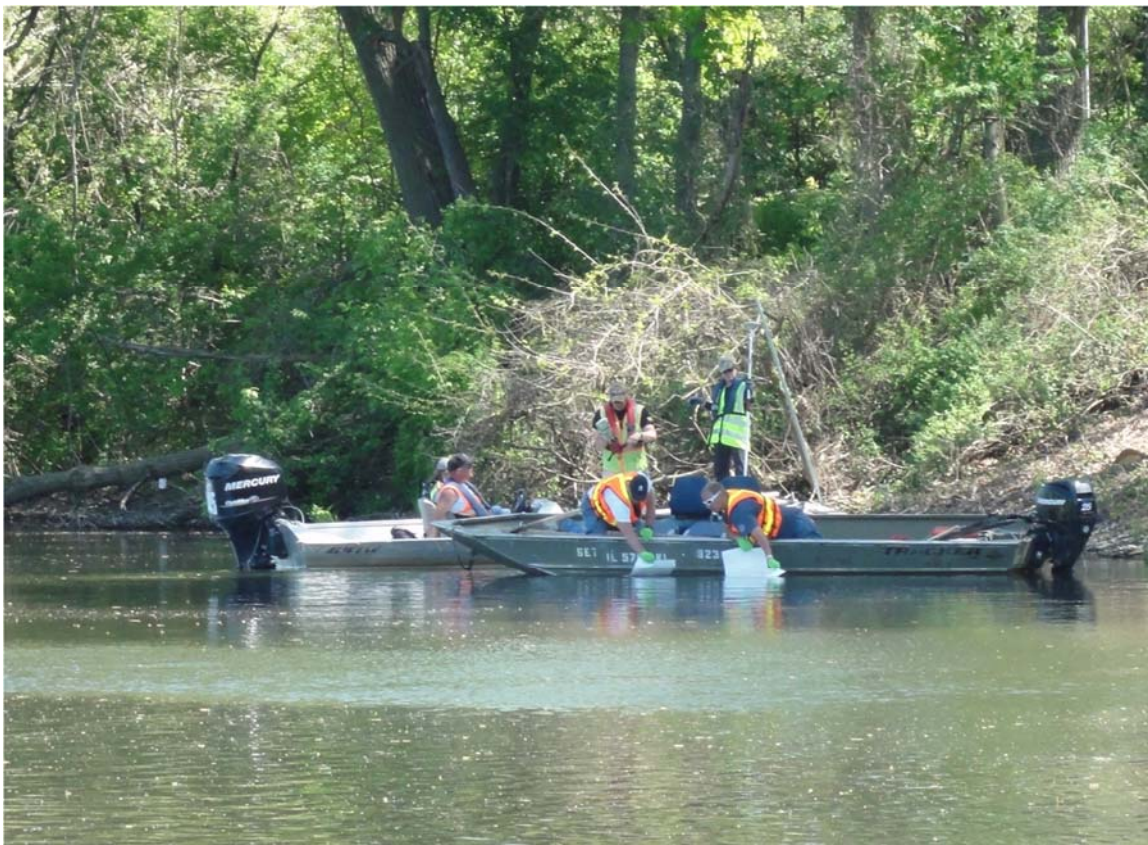
16. Ceresco Dam support boat observed cleaning up oil and sheen generated by poling activities.

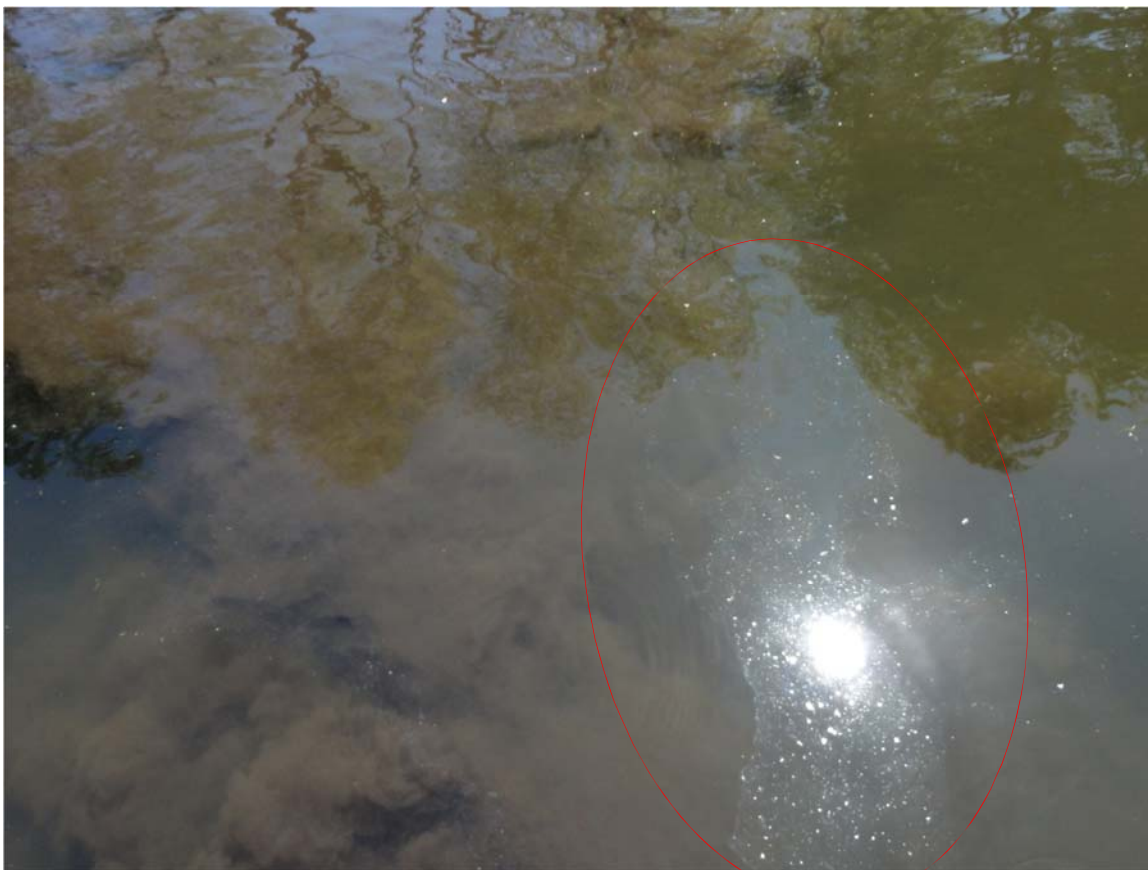
17. Ceresco Dam jet boat reverse thrust agitated sheen to the surface.

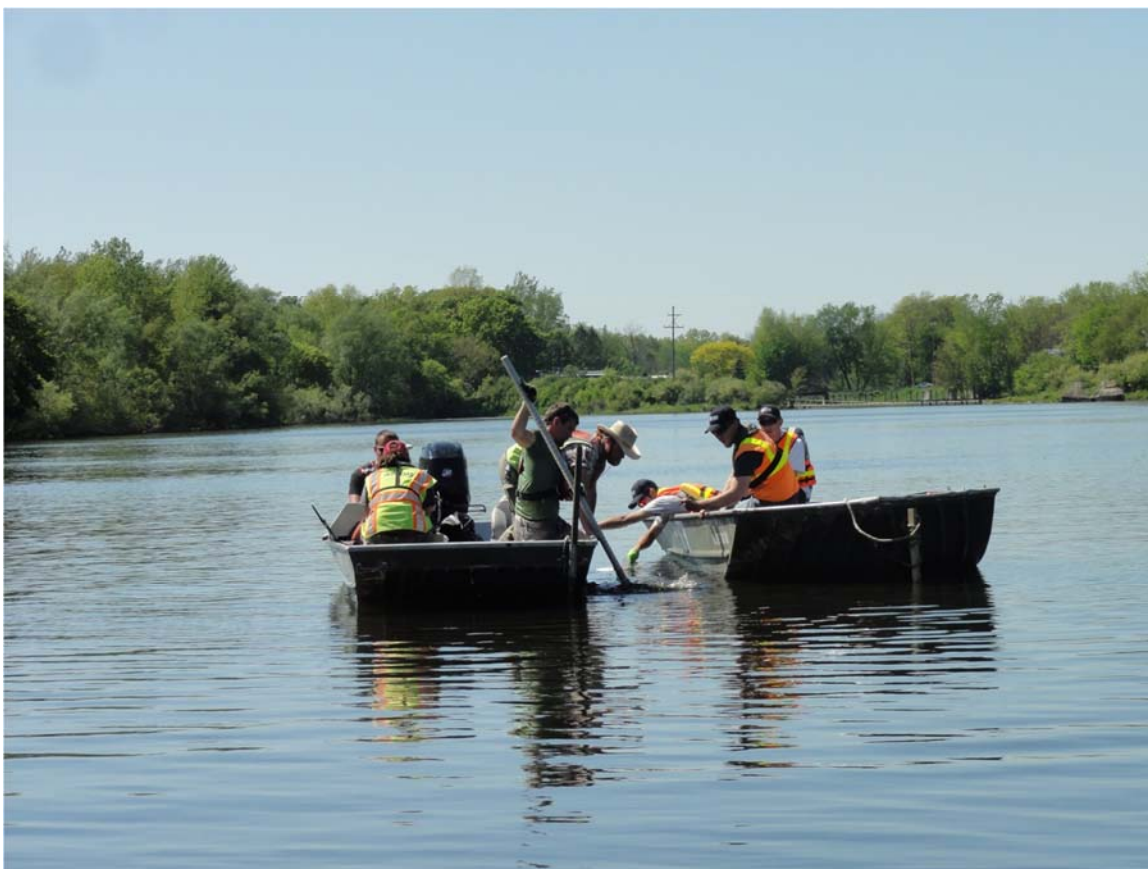
18. MP5.5 Poling crew and support boat observed.

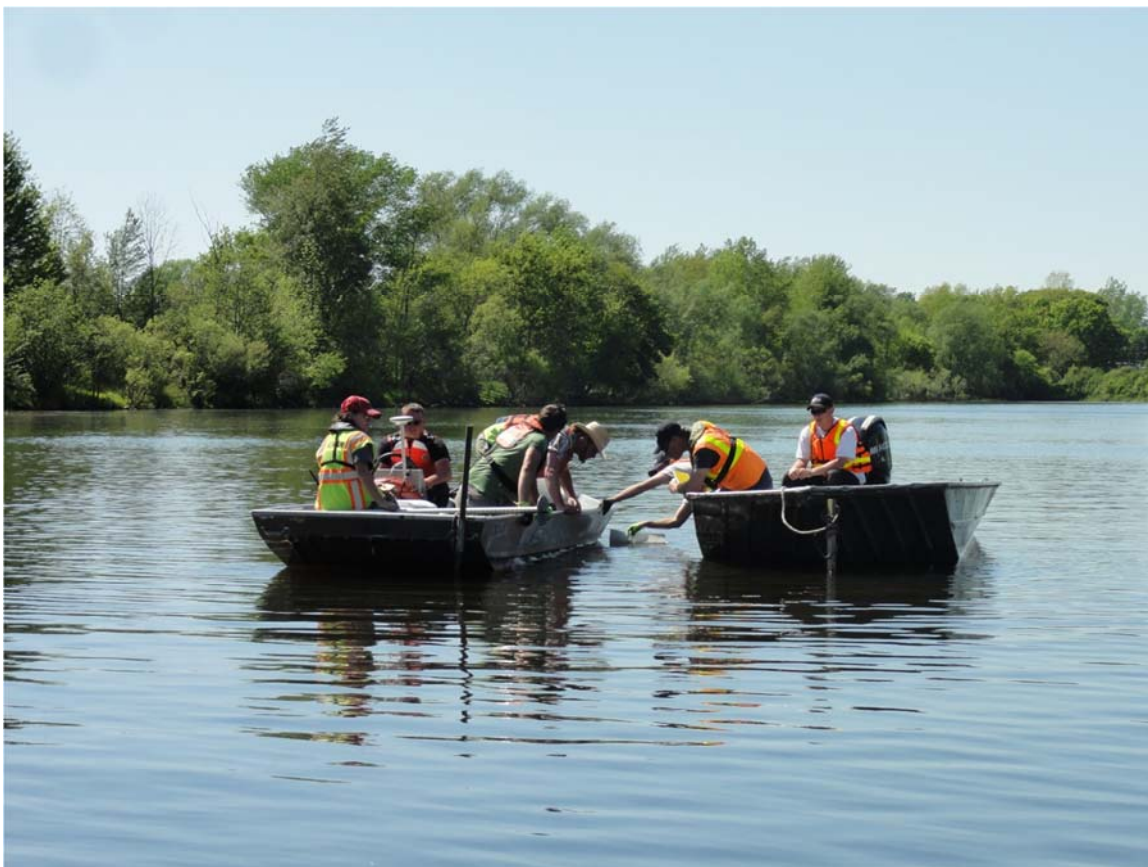
19. MP5.5 Poling crew and support boat observed.

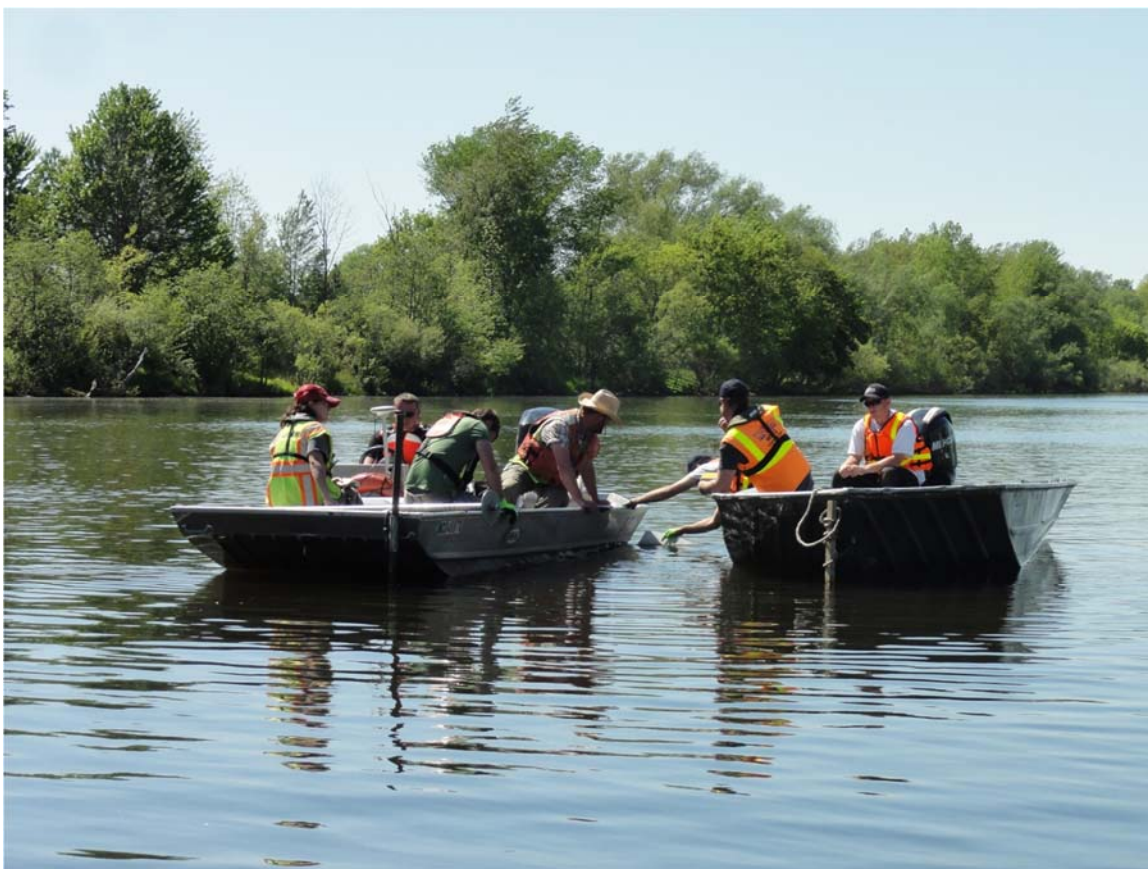
20. MP5.5 support boat observed cleaning up oil and sheen generated by poling activities.
